DAMAGE MECHANISMS AND FAILURE OF 3-D CARBON-CARBON COMPOSITES.(U)

# DAMAGE MECHANISMS AND FAILURE OF 3-D CARBON-CARBON COMPOSITES

Interim Report for Period August 1977 - August 1978  
Contract N00014-77-C-0510

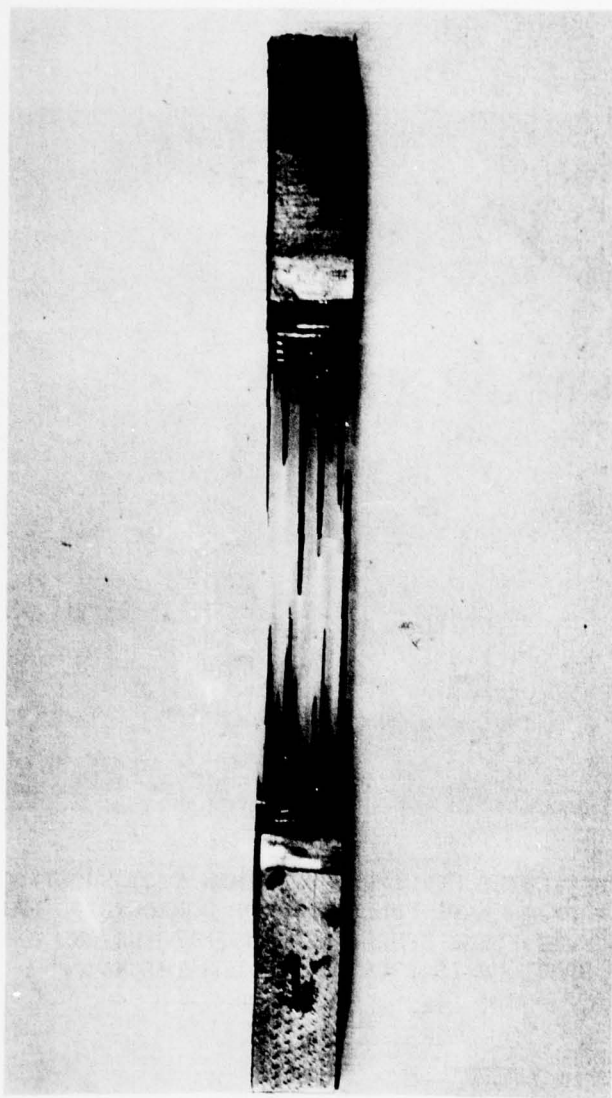
FIGURE 29. FAILED TENSILE SPECIMEN (SPECIMEN TT-1)  
SHOWING SOME FIBERS WHICH PULLED COM-  
PLETELY OUT OF THE SURROUNDING STRUCTURE.  
SPECIMEN IS TWO UNIT CELLS THICK.

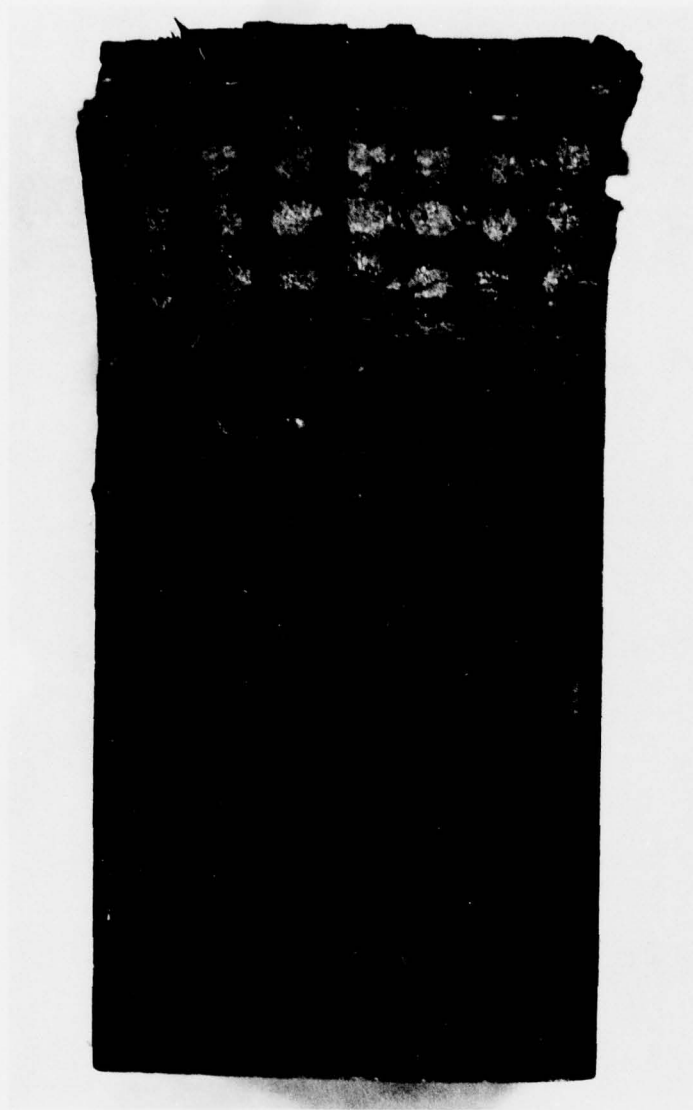
FIGURE 30. FAILED COMPRESSION SPECIMEN (SPECIMEN C-24)  
SHOWING BROOMING PHENOMENON.

Several interesting phenomena were observed during post-test examinations of the compression samples. The most obvious damage was a "brooming" effect (Figure 30). As mentioned earlier, this effect became obvious after the specimen had ceased to carry peak load. It is not believed that this damage mechanism had any effect on the ultimate strength, but once the specimen began to crumble in this manner, it continued doing so at a lower load than was required to initiate the process. This brooming phenomenon was found in specimens oriented in both the y- and z-directions.

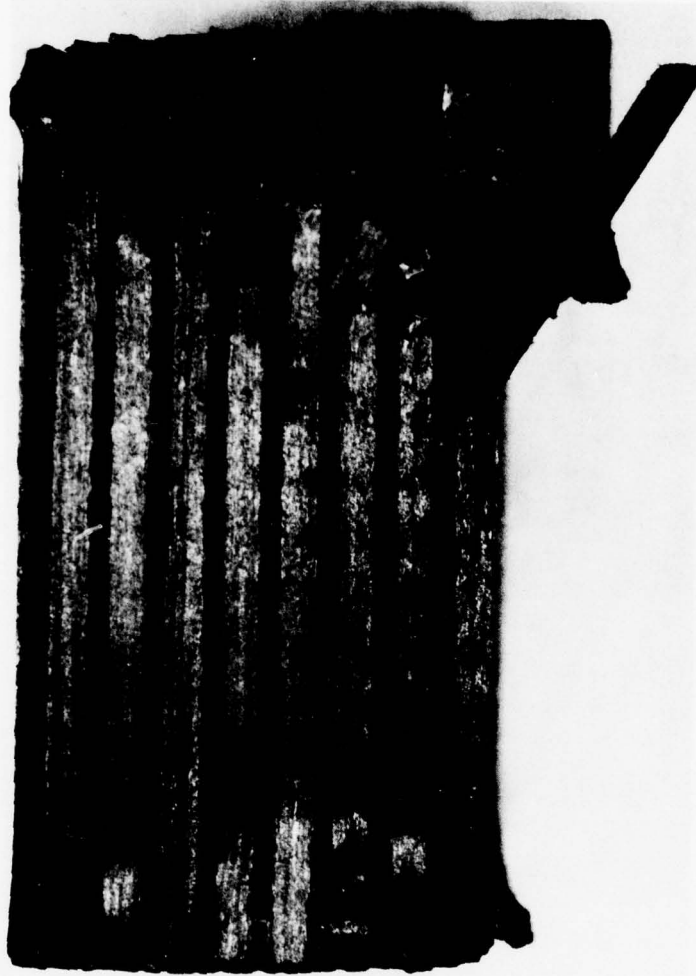
FIGURE 33. FAILED COMPRESSION SPECIMEN (SPECIMEN C-11, Z-DIRECTION) SHOWING SHEAR-LIKE FAILURE. TEST TEMPERATURE WAS 1930°C (3500°F).

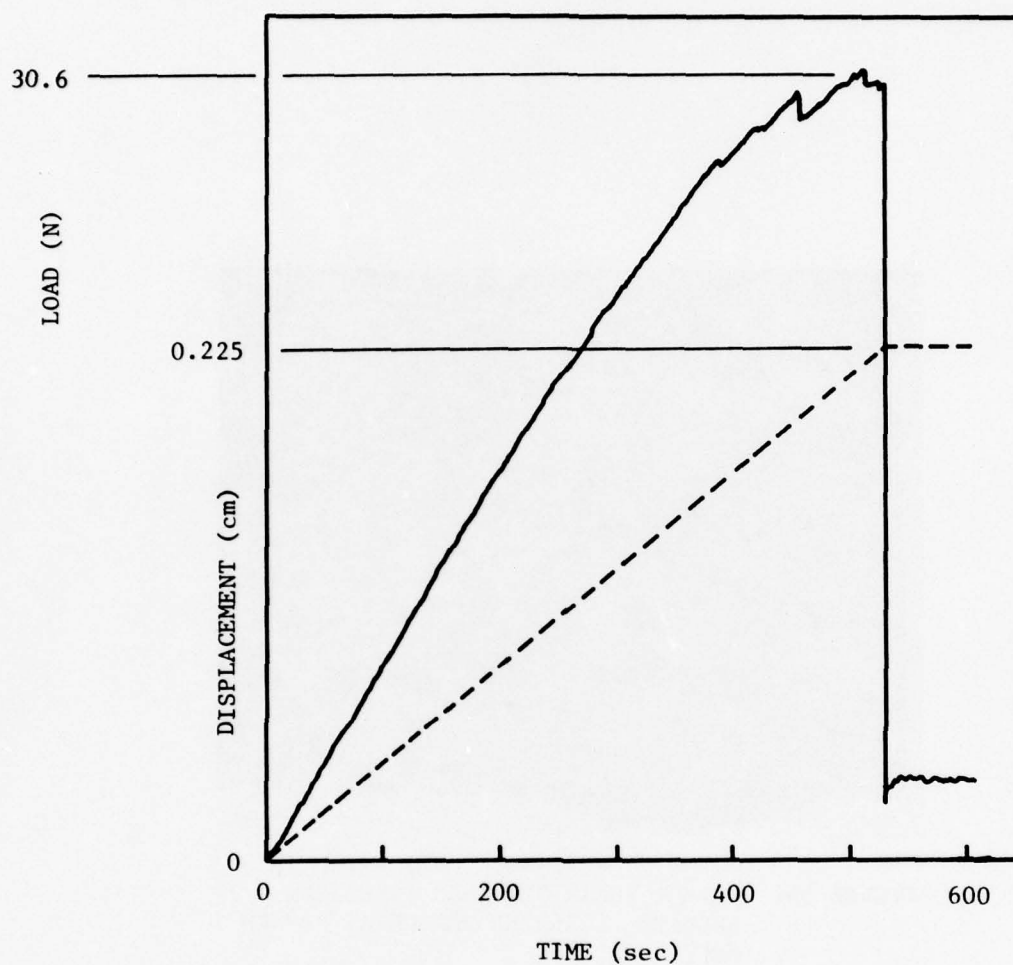
FIGURE 34. LOAD VERSUS DISPLACEMENT CURVE FOR HIGH TEMPERATURE (1930°C, 3500°F) COMPRESSION TEST, SHOWING SUDDEN, CATASTROPHIC FAILURE. THE BROKEN LINE IS DISPLACEMENT AND THE SOLID LINE IS THE CORRESPONDING LOAD. (SPECIMEN C-11, Z-DIRECTION).

Characterization of the stress-strain curves for the compression tests indicates that most of the specimens failed gradually with increasing load. However, specimens C-11 and C-12 failed suddenly and catastrophically as shown in Figure 34. Even though C-20 had an oblique failure surface, it did not fail catastrophically as did C-11 and C-12. It appears that the higher temperatures have a tendency to render the matrix material somewhat stronger and more brittle. This would explain the shear-mode failure surfaces and the more sudden failures as well as the slightly higher compressive strengths at the high temperatures.

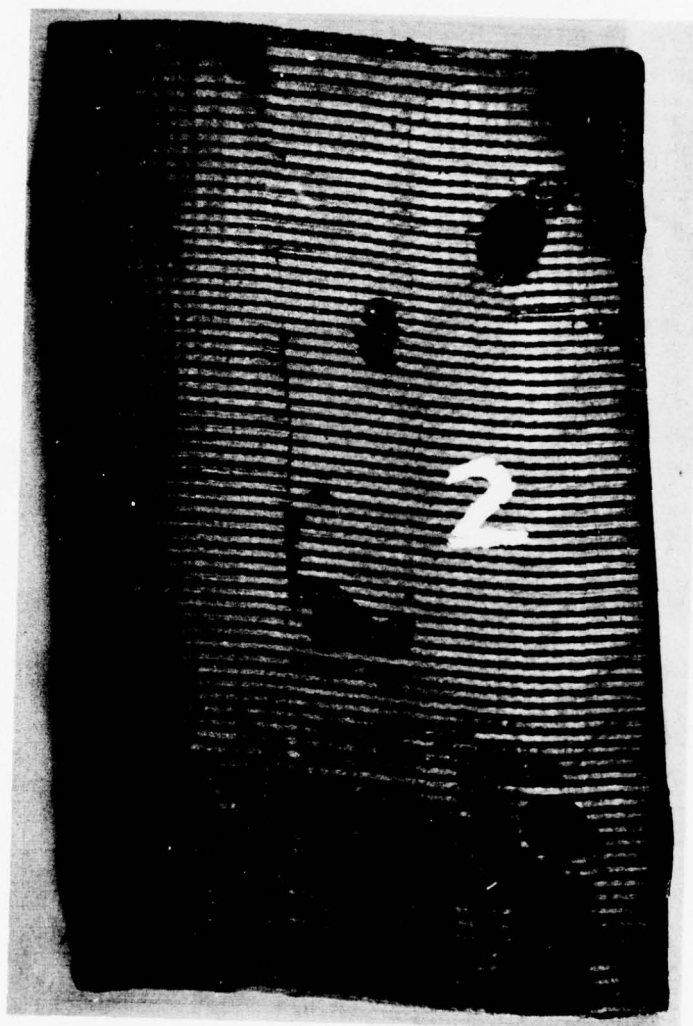
FIGURE 36. FAILED SHEAR SPECIMEN (SPECIMEN S-2)  
SHOWING LARGE AMOUNT OF PLASTIC  
DEFORMATION.

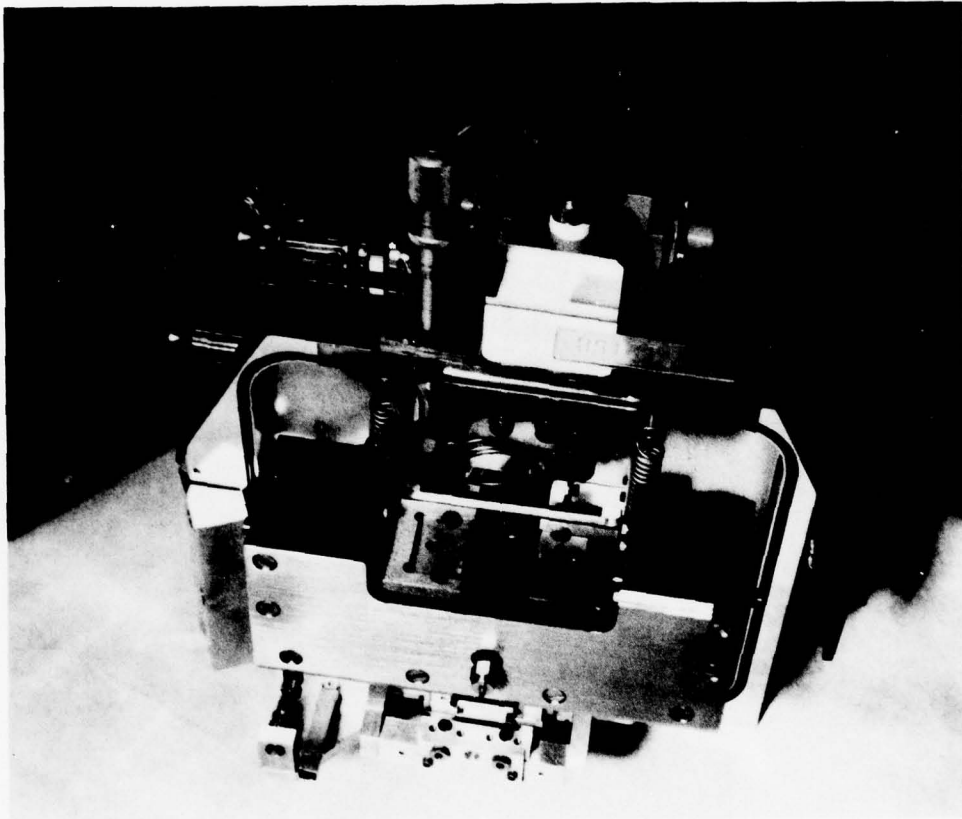
FIGURE 38. LOADING STAGE FOR ETEC AUTOSCAN  
SCANNING ELECTRON MICROSCOPE.  
CARBON-CARBON SPECIMEN IS SHOWN  
LOADED IN STAGE.

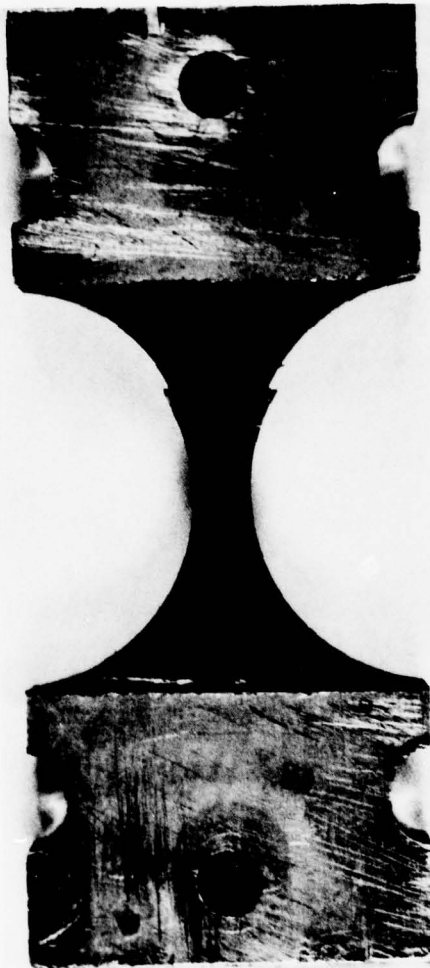
FIGURE 39. TYPICAL SEM SPECIMEN. LOAD IS TRANSMITTED THROUGH THE EDGE NOTCHES IN THE TABS. THE CENTER HOLES ARE MERELY FOR ALIGNMENT PURPOSES.

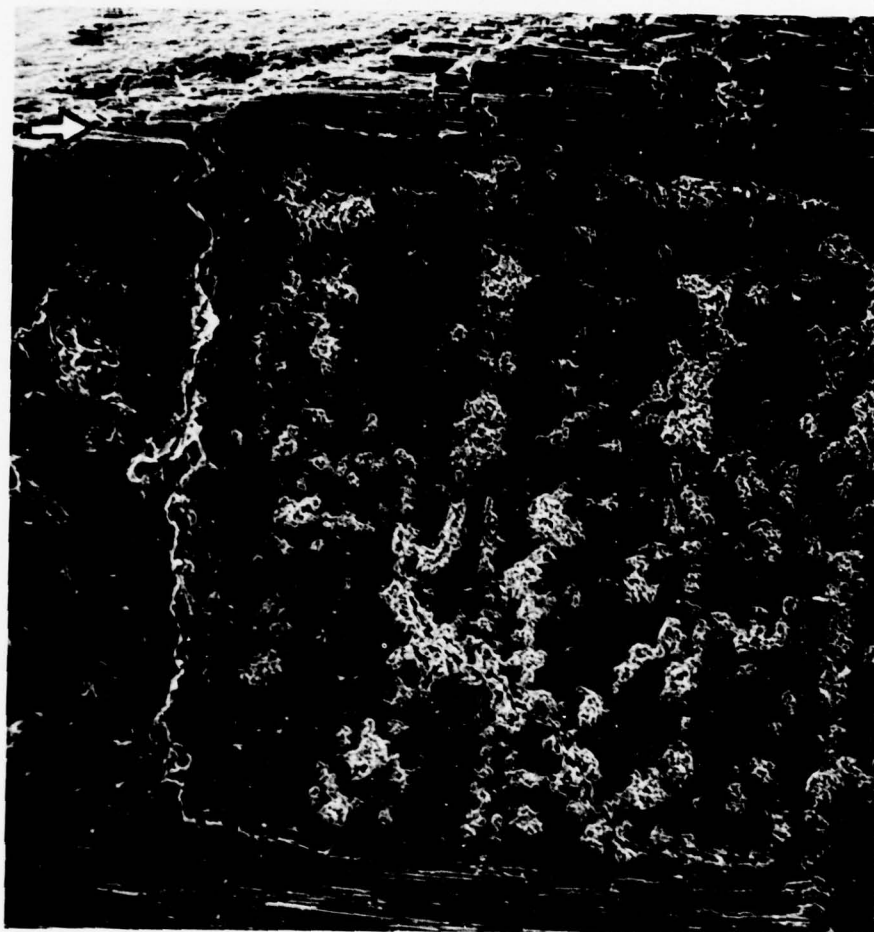
FIGURE 40. SEM PHOTOGRAPH (SPECIMEN SEM-14) SHOWING CRACK WHICH INITIATED IN SHEAR (WHITE ARROW), PROPAGATED OPENING MODE, AND FINALLY TURNED  $90^\circ$  (TO SHEAR MODE AGAIN) AND RAN ALONG FIBER BUNDLE. 120X, 73 MPa (10.5 ksi). (LOADING DIRECTION IS OUTWARD IN HORIZONTAL DIRECTION).

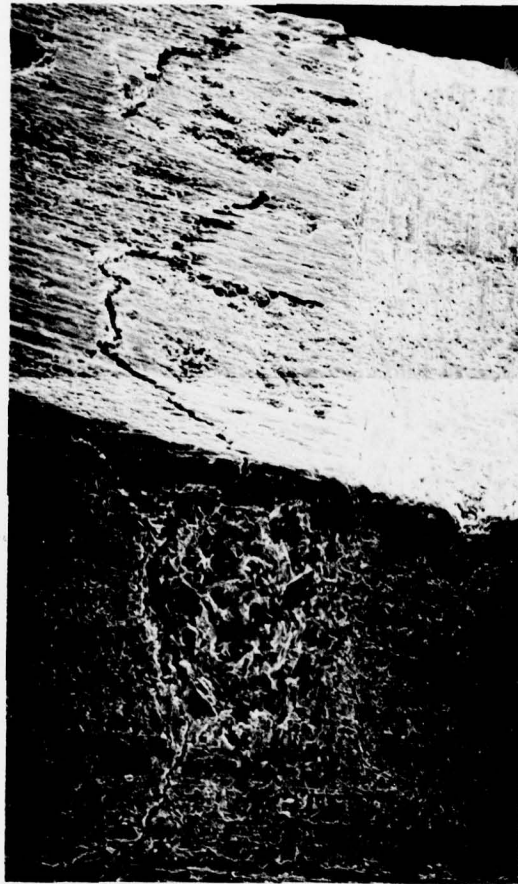
FIGURE 41. SEM PHOTOGRAPH (SPECIMEN SEM-14) SHOWING CRACK RUNNING ACROSS TOP EDGE AND DOWN FRONT FACE OF SPECIMEN. 60X, 76 MPa (11.0 ksi).

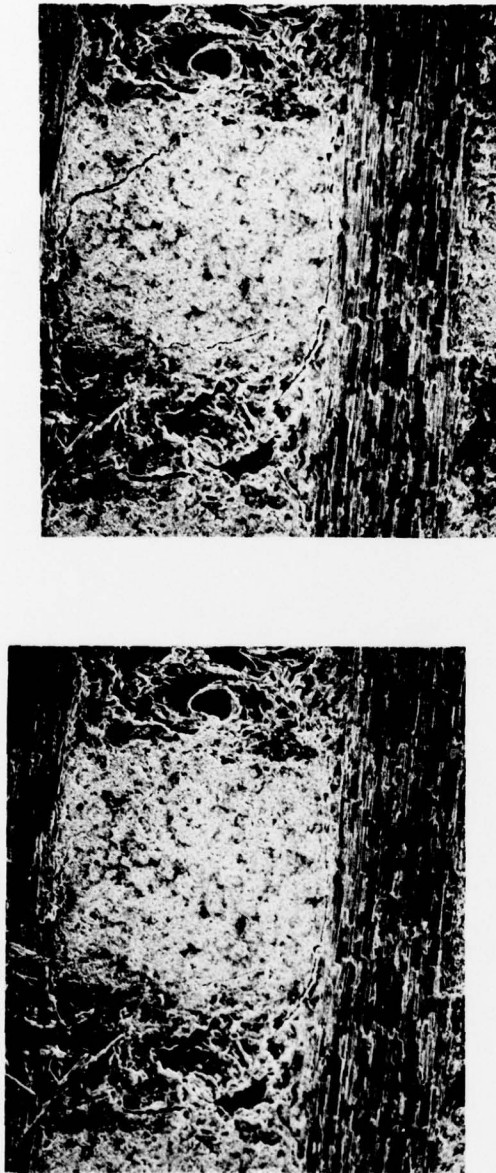
FIGURE 42. STEREO PAIR OF CRACK NETWORK (SPECIMEN SEM-20).  
40X, 15.9 MPa (2.30 ksi) FOR 42(a) and 66.2 MPa  
(9.60 ksi) FOR 42(b). HORIZONTAL DISPLACEMENT  
DIFFERENCES WILL APPEAR AS NORMAL DISPLACEMENTS  
WHEN STEREO PAIR IS CORRECTLY ALIGNED.

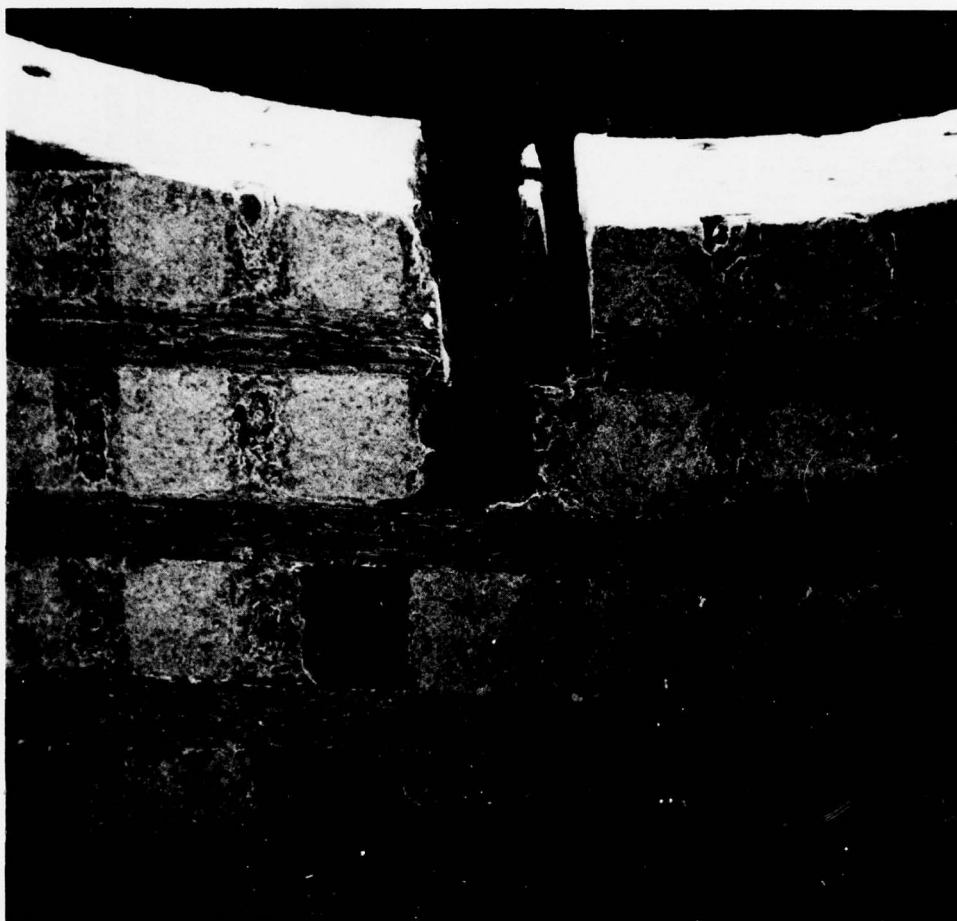
FIGURE 43. FAILED SEM SPECIMEN (SPECIMEN SEM-20), AT 17X.  
STARTER NOTCH (TOP OF SPECIMEN) PASSED THROUGH  
TOP FIBER BUNDLE.

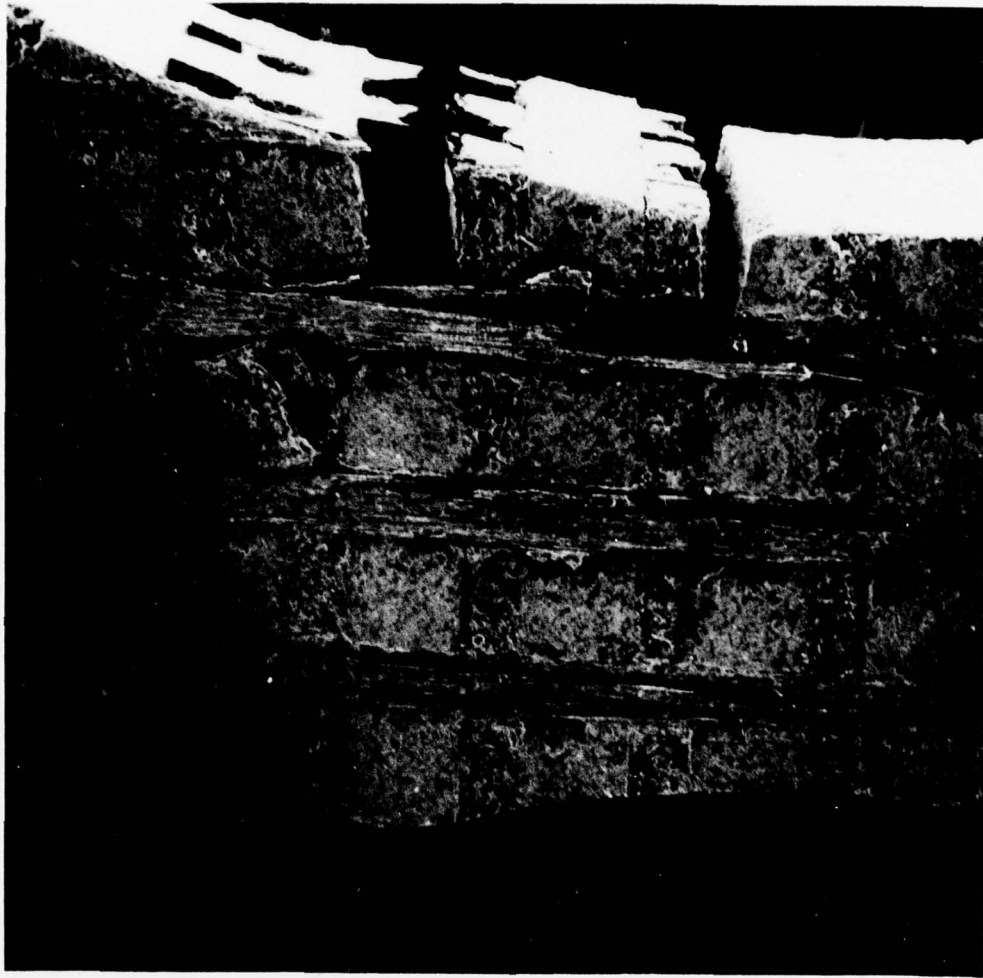
FIGURE 44. FAILED SEM SPECIMEN (SPECIMEN SEM-21), AT 17X.

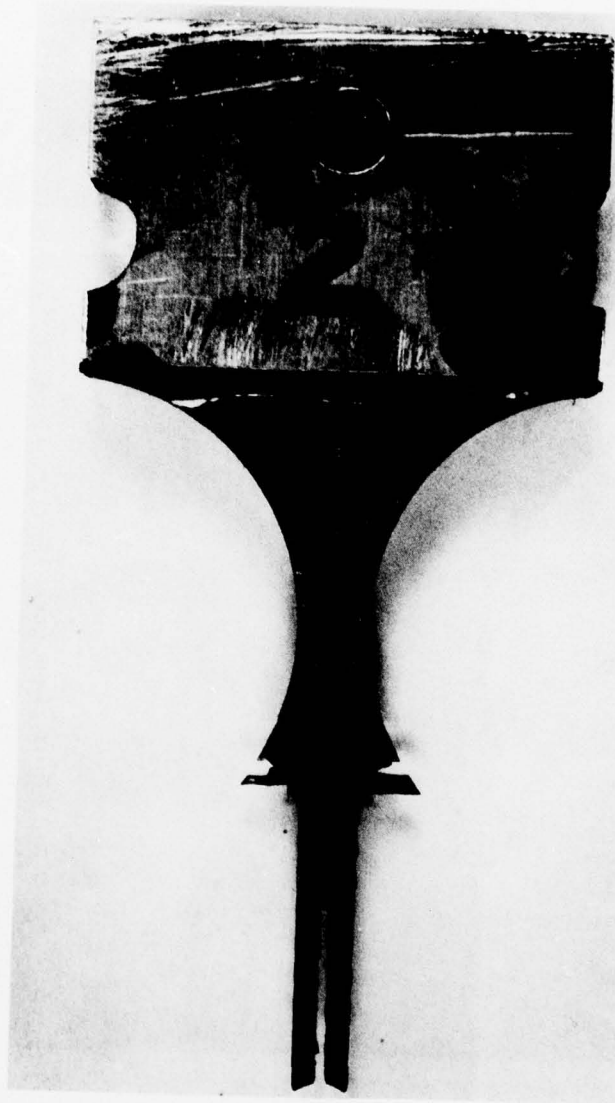
FIGURE 45. FAILED SEM SPECIMEN (SPECIMEN SEM-2, Z-DIRECTION).

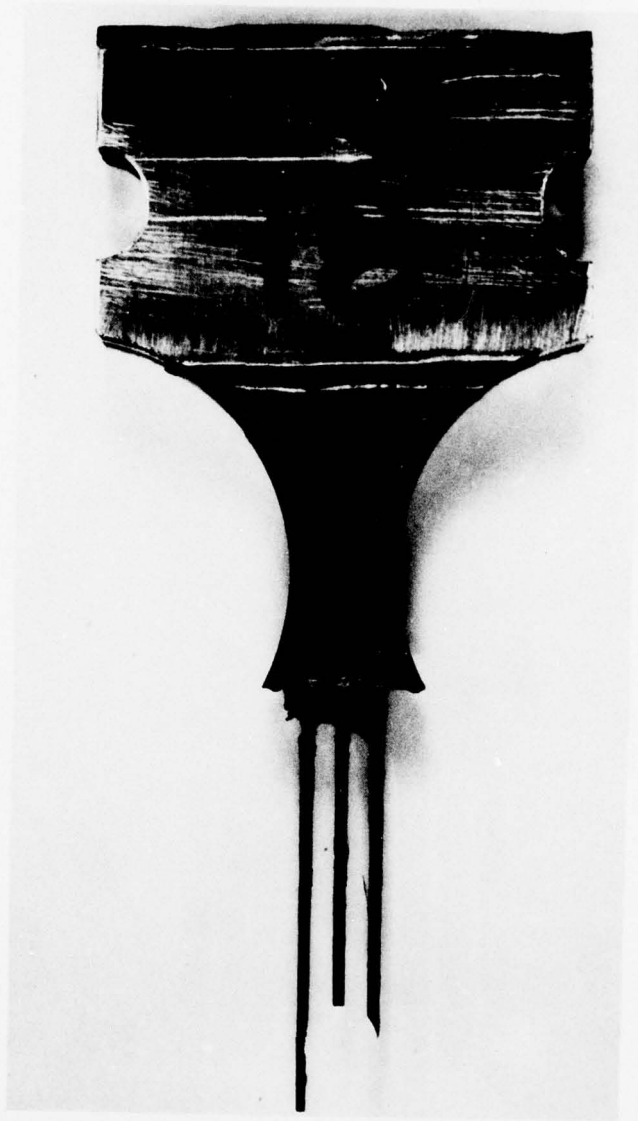
FIGURE 46. FAILED SEM SPECIMEN (SPECIMEN SEM-18, Y-DIRECTION).

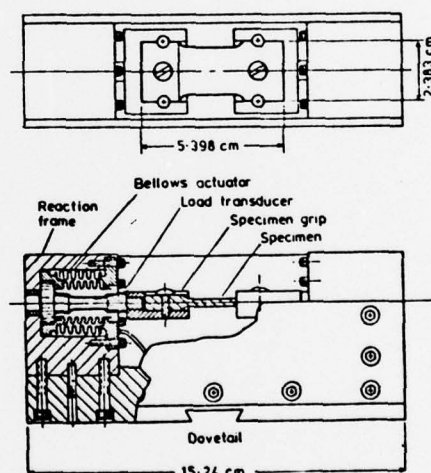
Figure 2 Loading system assembly with specimen.
